# RECALL CAMPAIGN BULLETIN

87PTH

September 14, 1987

## **VOLUNTARY RECALL CAMPAIGN 1987 PATHFINDER (VINYL SEATS) REAR SEAT BELT**

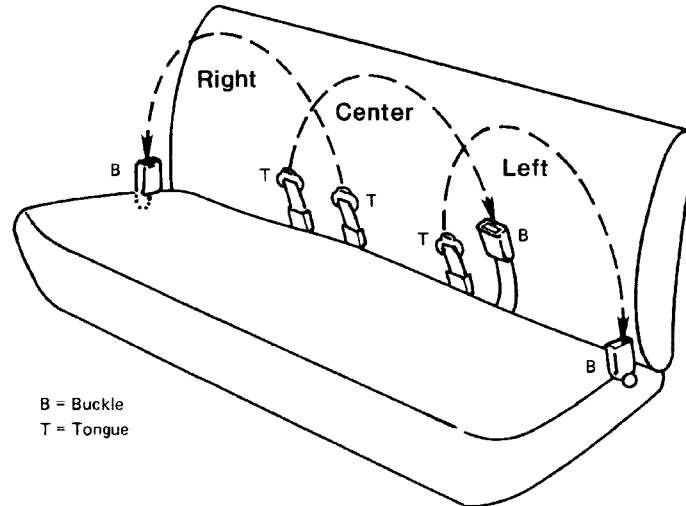
Because of an error in the parts preparation process, mismatched male and female rear seat belt sets were supplied on some 1987 Pathfinder vehicles. On those vehicles, one or more rear seat belts will not latch because the male portion of the buckle is incorrect.

1. Check all three rear seat belt sets to be sure they buckle properly, making sure to match center and outer pairs as shown.

2. If one or more belt sets do not buckle, order the correct part number from the table below.
3. Remove the incorrect belt set, install the proper belt set, and torque anchor bolt to 35.8-45.6 N-M (3.65-4.65 kg-m, 26.4-33.6ft-lb) as shown on page MA-77 of the July 1986 (03) printing of the Service Manual.
