RECALL CAMPAIGN BULLETIN

NTB08-003

**VOLUNTARY EMISSIONS RECALL CAMPAIGN
2008 PATHFINDER V-8 EMISSION LABEL****CAMPAIGN I.D. #** R0714**APPLIED VEHICLE:** 2008 Pathfinder (R51) with V-8 engine**APPLIED VINs:** 5N1BR18**8C 600000 - 644269**INTRODUCTION**

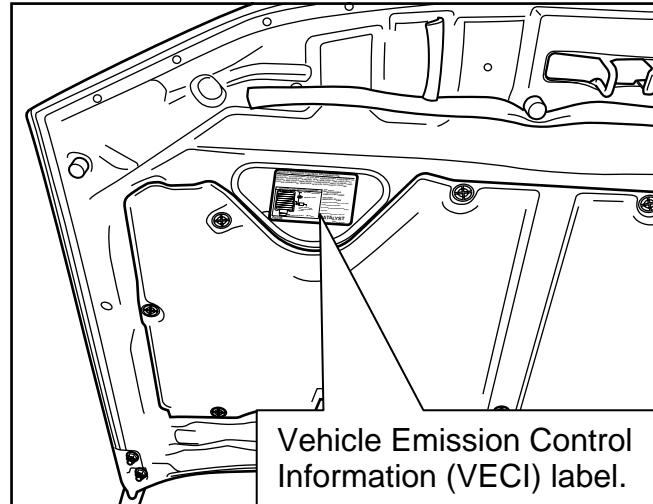
Figure 1

5. Locate the existing under-hood VECI label.
6. Clean the label and the area around it with a mild detergent and water.

- Care should be taken not to use harsh chemicals that may damage the existing label.
- It is important the surface be free of dirt and oil to ensure proper adhesion of the new label.

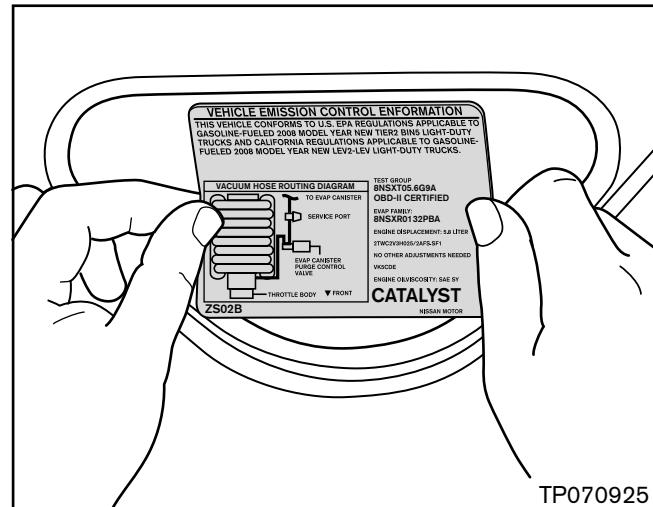
Figure 2

7. Completely dry the label and the area around it.
8. Peel the new label from the backing sheet and install it directly over the top of the existing label.

NOTE: The adhesive on the label is permanent. Extra care should be taken when applying the new label since it can not be moved once it is attached.

NOTE: DO NOT REMOVE THE EXISTING VEHICLE EMISSION CONTROL INFORMATION (VECI) LABEL. Install the replacement label over the top of the existing label.
